Chicora Research Contribution 552

Preservation Assessment of Tolson's Chapel Cemetery, Sharpsburg, Maryland

Prepared By:
Michael Trinkley, Ph.D.
and
Debi Hacker

May 1, 2013

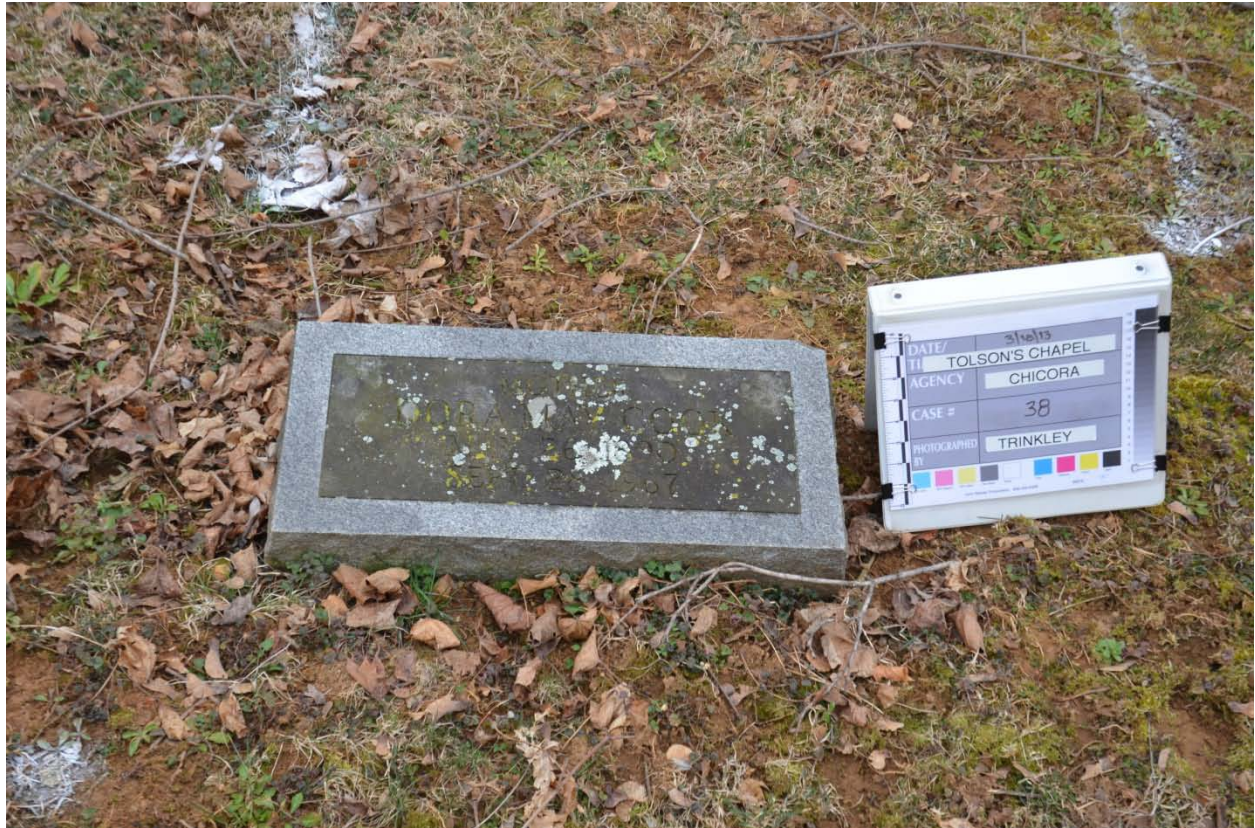
Deterioration: ☐ broken ☐ cracked ☒ losses ☐ flaking/sugaring ☐ ferrous pins ☐ brass pins
☐ delamination/detachment ☐ spalling ☐ missing fragments ☒ other: mower damage

Soiling: ☒ biological ☐ staining ☐ efflorescence ☐ other:

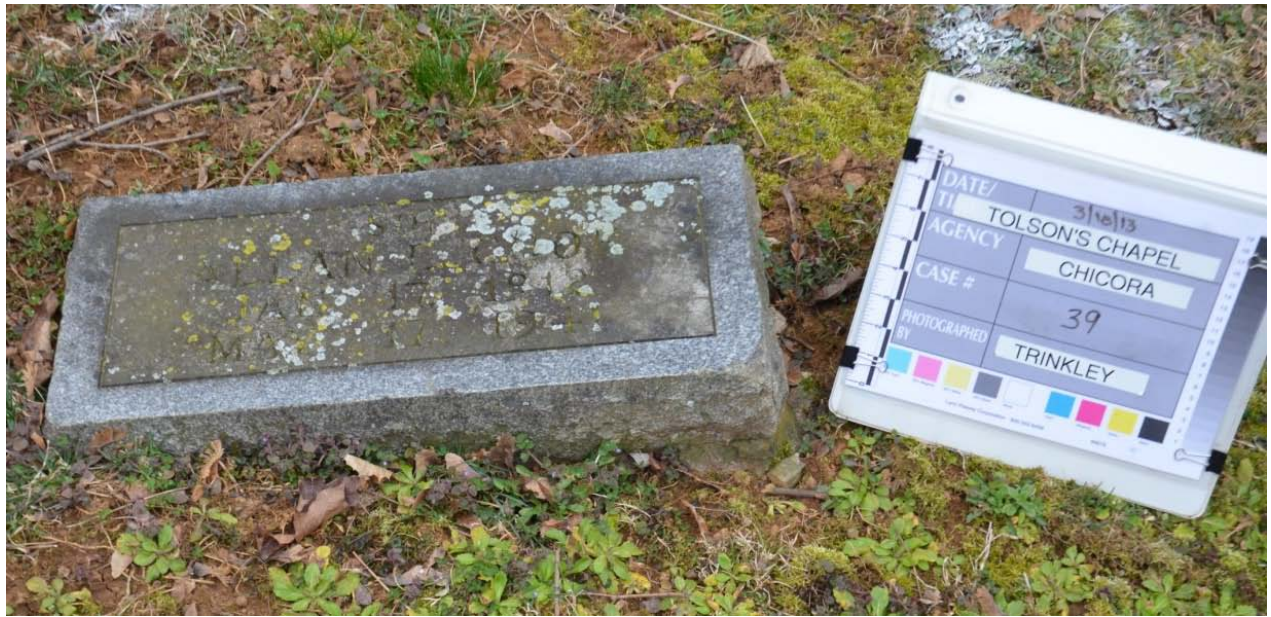
Position: ☐ fallen ☒ tilted ☐ unstable ☐ unattached/loose ☐ missing

Deterioration: ☐ broken ☐ cracked ☒ losses ☐ flaking/sugaring ☐ ferrous pins ☐ brass pins
☐ delamination/detachment ☐ spalling ☐ missing fragments ☒ other: mower damage

Soiling: ☒ biological ☐ staining ☐ efflorescence ☐ other:
